# Arborist Report

## Glenview Terrace San Bruno CA

***Prepared by:***  
HortScience | Bartlett Consulting  
2550 Ninth Street, Suite 112  
Berkeley, CA 94710

October 2023

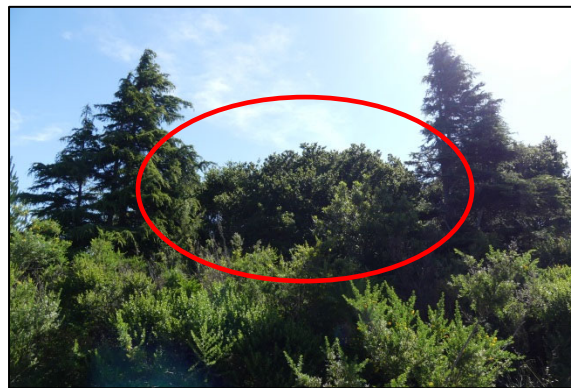
Coast live oak was the most frequently occurring species with 22 trees (Photo 1). Trees ranged from young to mature in development. Trunk diameters varied from 6- to 27-inches in diameter. Most stems were 12-inches or smaller in diameter. Approximately 50% of oaks had more than one stem that arose close to the ground.

**Photo 1.** Looking east towards dense area of coast live oaks (red circle) and toyon trees.

Tree condition was generally fair (14 trees). Five oaks were in poor condition while tree #105, 107, and 140 were good. The primary factor influencing tree condition was growing space and competition for it. Oaks were often crowded, leading to asymmetric form and structure, and high crowns. Trees in poor condition were suppressed in development.

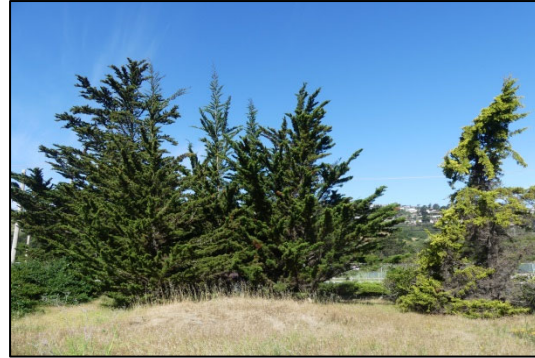
Ten Monterey cypresses were present (Photo 2). Trees ranged from young to mature in development with trunk diameters between 6- and 25-inches. Five trees were in fair condition and cypress #115 was poor. In contrast, trees #117, 120, and 121 were in good condition and cypress #122 was excellent. Most trees lacked vigor and had thin canopies of foliage, likely due to a long history of water stress and lack of irrigation.

**Photo 2.** Several Monterey cypresses were clustered together near Glenview Drive.
