# GEOTECHNICAL INVESTIGATION FLORIDA AVENUE PARK

SAN BRUNO, CALIFORNIA

**SUBJECT: Geotechnical Investigation**  
**RE: Florida Avenue Park**  
**San Bruno, California**

**GEOTECHNICAL INVESTIGATION  
FLORIDA AVENUE PARK  
San Bruno, California**

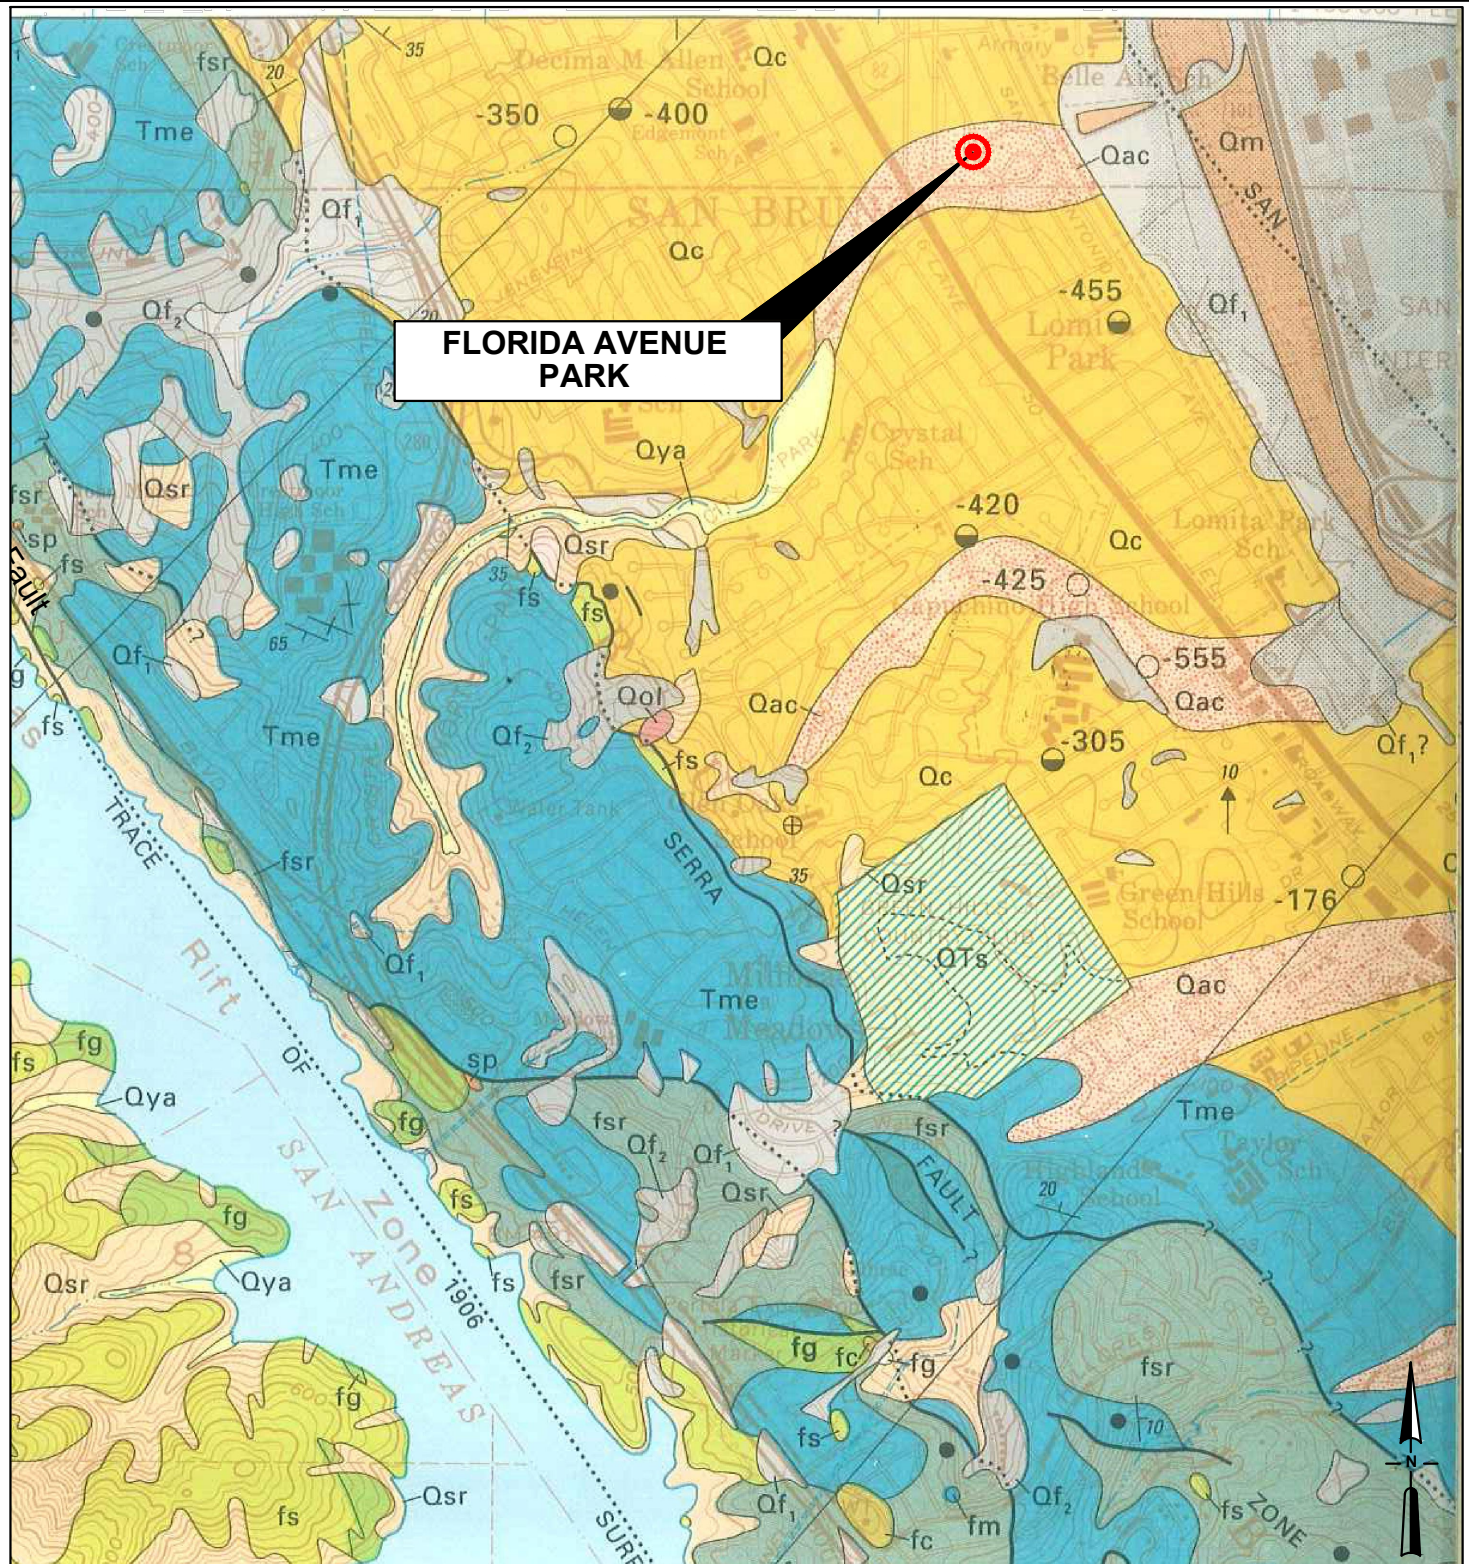
**FLORIDA AVENUE  
PARK**

**Geologic Unit**

The Florida Avenue Park site is located adjacent to margin of the San Francisco Bay. Historically, the tidal marshes appear to have been located roughly ¼ mile to the east. The historic the mouth of El Zanjon Creek appears have been located at or just south of the proposed Florida Avenue Park site (Tillery, Sowers and Pearce). The site is mapped as being underlain by coarse-grained alluvium (Geologic Map of the Montara Mountain and San Mateo 7-1/2' Quadrangles, San Mateo County, California; see attached Figure 2, Regional Geologic Map).

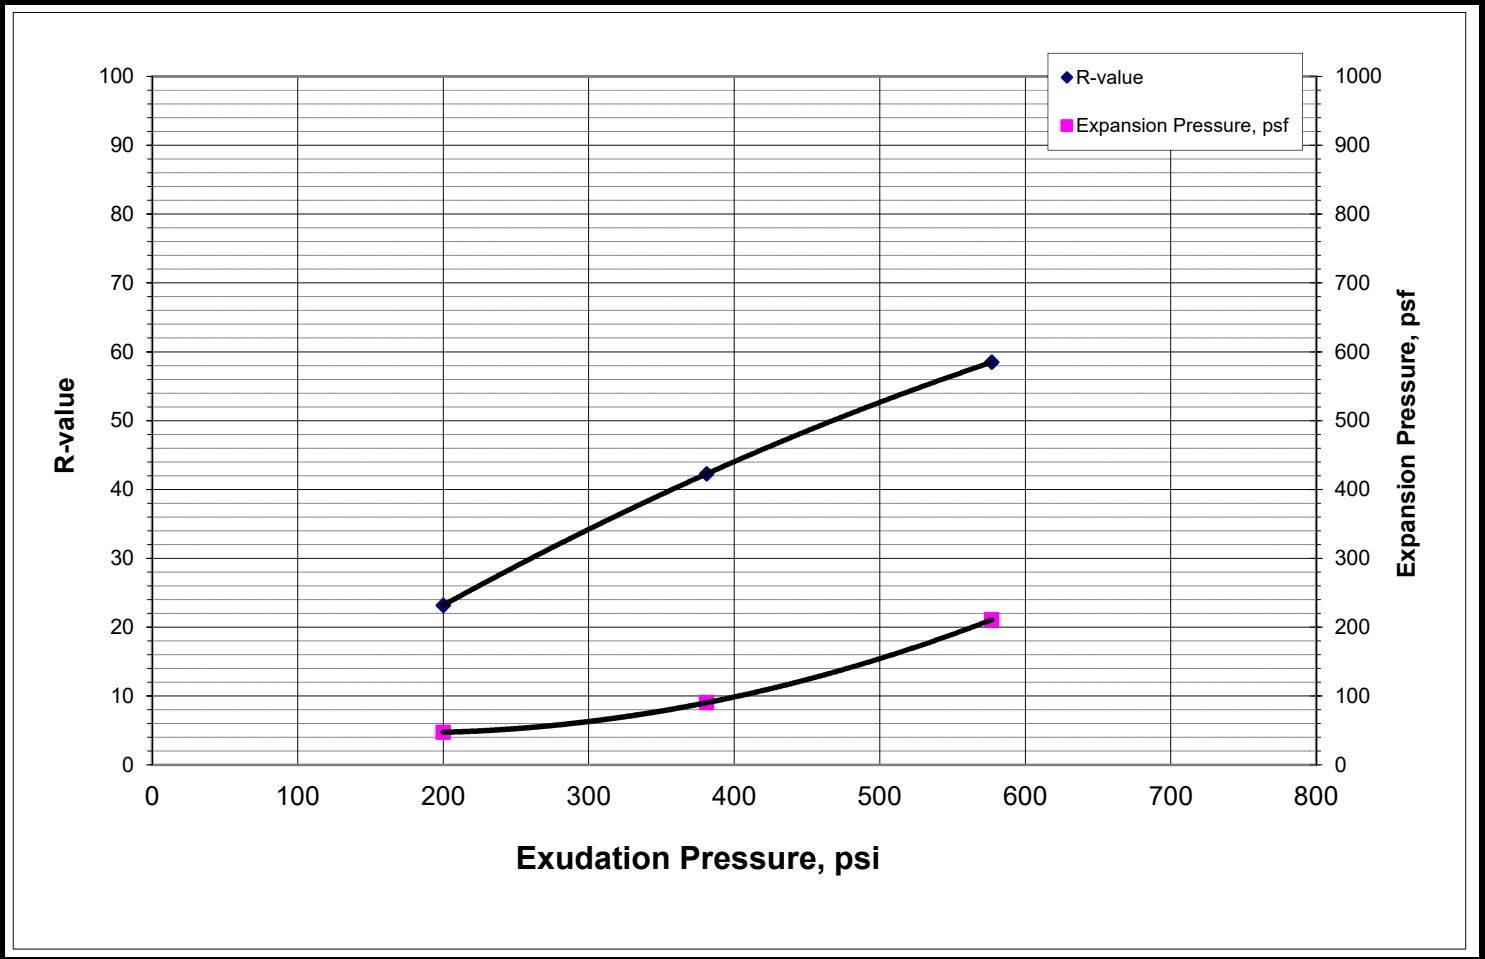
| Specimen Number | A | B | C | D | Remarks: |
|---|---|---|---|---|---|
| Turns Displacement | 3.10 | 3.20 | 3.02 | | |
| R-value | 23 | 42 | 58 | | |
